Recall Bulletin

File In Section: Product Recalls
Bulletin No.: 03020
Date: August, 2003

SUBJECT: 03020 - DRIVER'S SAFETY BELT BUCKLE

MODELS: 1997 CHEVROLET BLAZER
1997 GMC JIMMY
1997 OLDSMOBILE BRAVADA

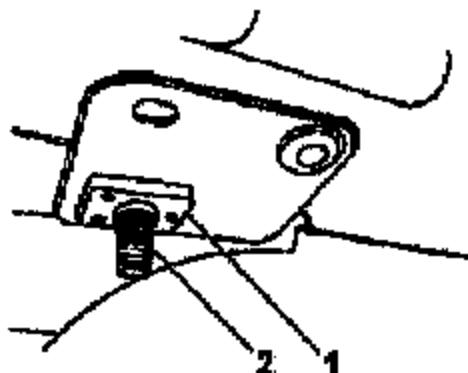
1308219

10. From underneath the vehicle, locate the end of the new bolt (2) and the original weld nut (1).

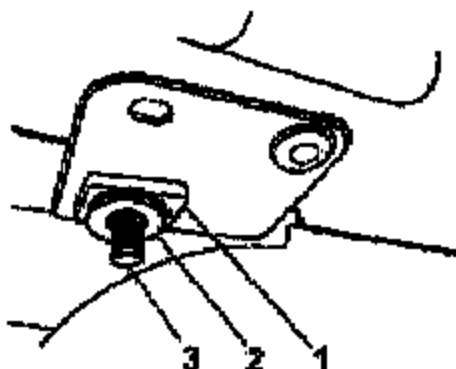
1388220

11. Install TWO washers (2), P/N 15614782, over the end of the new bolt (3) and up to the weld nut (1) that is attached to the floor pan. The lip on the weld nut must fit inside of the holes in the washers.

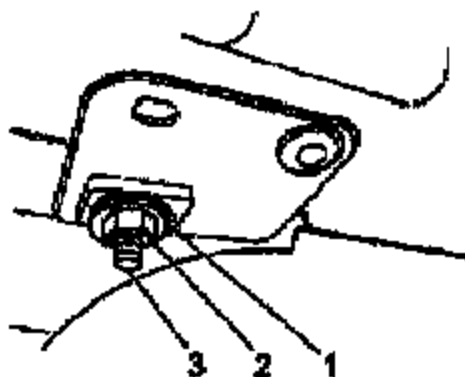
1388221

12. With the washers (1) in position, install a new loose nut (2), P/N 11516073, on the new bolt (3). **Tighten**

Tighten to 70 N·m (52 lb ft).

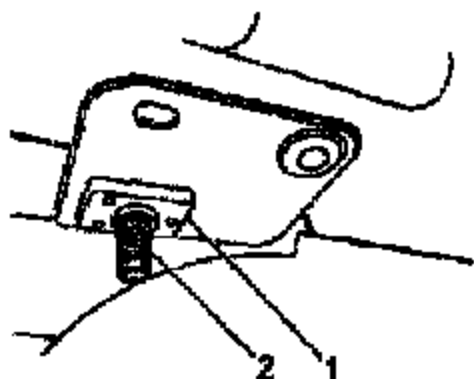
1386219

6. From underneath the vehicle, locate the end of the new bolt (2) and install the original weld nut (1) with the small lip around the hole in the weld nut facing downwards. Do not re-weld the weld nut to the floor pan.

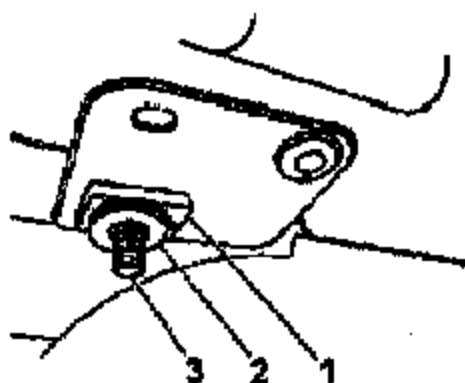
1386220

7. Install TWO washers (2), P/N 15614782 over the end of the new bolt (3) and up to the weld nut (1) that is attached to the floor pan. The lip on the weld nut must fit inside the holes in the washers.

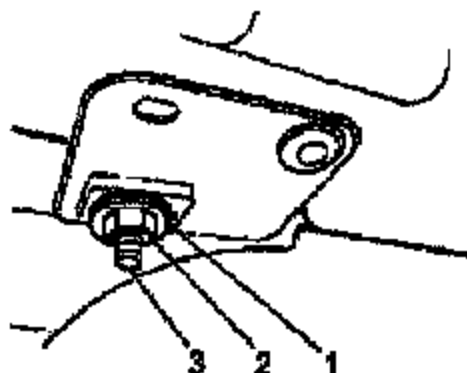
1386221

8. With the washers (1) in position install a new loose nut (2), P/N 11516073, on the new bolt (3). **Tighten**
